Manhole Inspection Summary

Manhole # S37EE1012MH

Insp Date: **2/21/07 10:01 AM**

Location Address: **3928 ARGONNE DR**

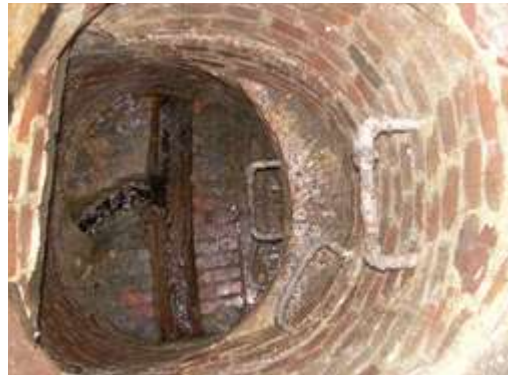
Top View

Evidence of surcharge - Bench debris.

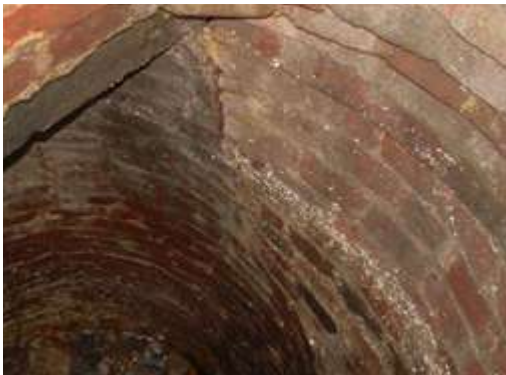
Defect

Adjustment, Corbel and Barrel infiltration.
Corbel cracks.

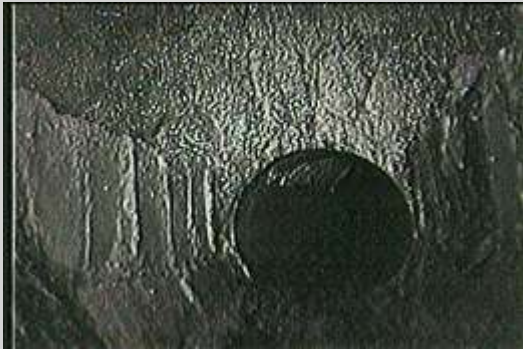
Pipe Out @ 12 O'Clock

8 in. Circular Gravity Sewer

Pipe Material: **Clay** ☐ Pipe Lined

Invert Depth: **9.32** (ft.) Flow Characteristics: **Slow**

Infiltration: **None** Pipe Seal Cond: **Unknown**

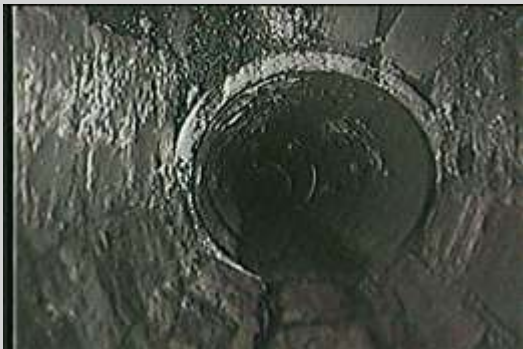
Pipe In @ 6 O'Clock

8 in. Circular Gravity Sewer

Pipe Material: **Clay** ☐ Pipe Lined

Invert Depth: **8.78** (ft.) Flow Characteristics: **Slow**

Infiltration: **None** Pipe Seal Cond: **Unknown**

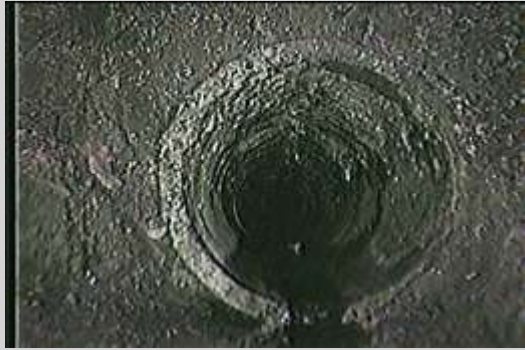
Pipe In @ 8 O'Clock

8 in. Circular Gravity Sewer

Pipe Material: **Clay**

Invert Depth: **8.59** (ft.) Flow Characteristics: **Slow**

Infiltration: **None**
